Promontory Point in Burnham Park

Promontory Point in Burnham Park 54th to 57th Streets in Chicago, Illinois

July 13, 2003

The Hyde Park Community's Proposal for the Preservation, **Restoration and Enhancement of the Historic Stepped Limestone Revetment System at Promontory Point**

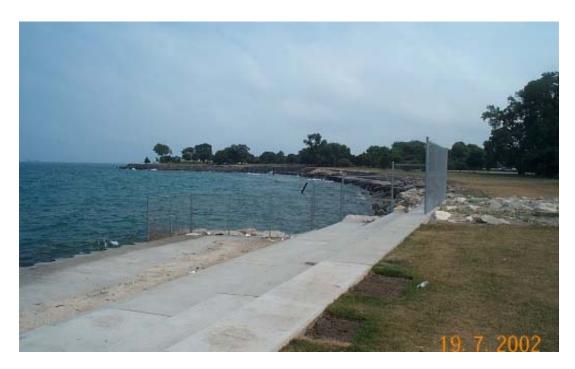
Segment NX (North Existing)

This photo recently completed concrete revetment to the north.

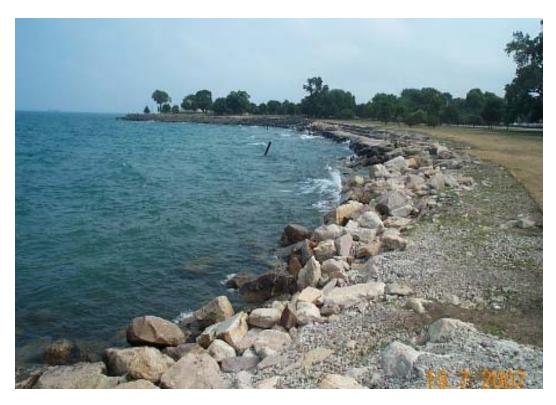
Segment A

This is just south of the recently completed concrete revetment, and illustrates the rubble stone repairs placed in the 1960s.

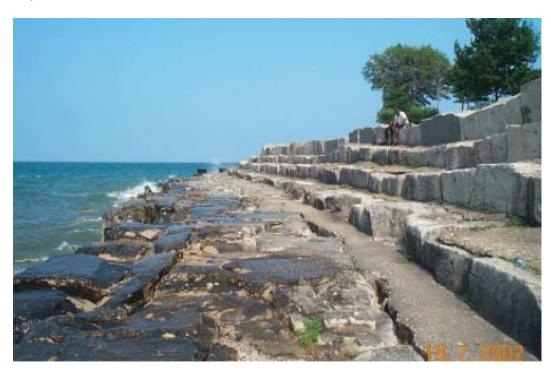
Segment B

The outer edge of the promenade has somewhat displaced due to deterioration of the tops of the wood piles. Water is very shallow due to littoral drift with sand accumulating along this segment. It is a favorite area for waders.

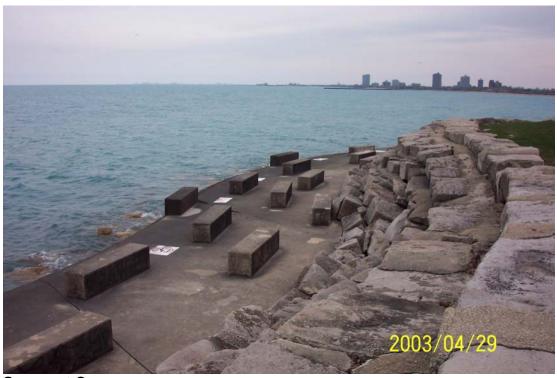
Segment C

Existing concrete platform constructed in 1963. Some scouring of supporting fill has occurred permitting revetment to sink.

- Existing concrete platform (promenade the "coffins") at east end of the Point is in good condition and will be preserved and repaired. Voids under concrete platform will be filled with a cement-sand mix. Stepped limestone revetment will be reconstructed.

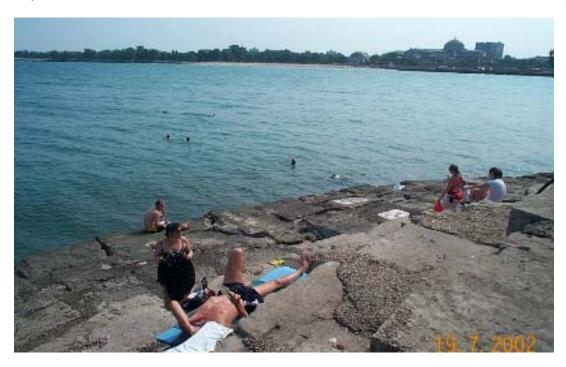
Segment D

This segment begins with the tip of the Point and curves around toward the south, creating a favorite area for sunning and deep water swimming.

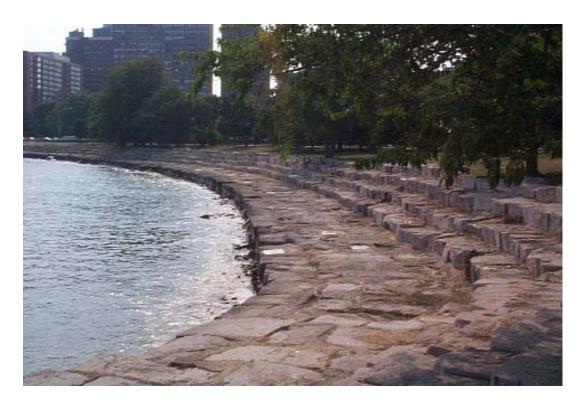
Segment E

Existing promenade and revetment are in good condition and can be preserved.

- Existing limestone step-stone revetment and promenade on south side of Point is in good condition and will be preserved and repaired as needed. Voids under stone will be filled with a cement-sand mix.

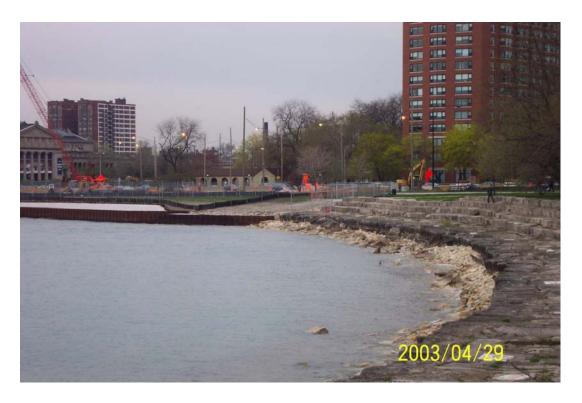
Segment F

This is a transition segment between new concrete and restored stone revetment. This segment is also in very good condition.

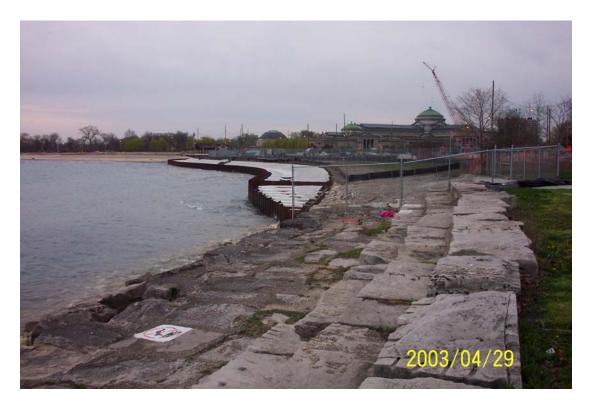
Segment SX

This photo shows the steel sheet piling currently under construction to the south and its transition to the existing limestone promenade.
